Case 267 : Narrative

Case Vehicle (A): 2000 Mercury	Vehicle (B): 1998 Ford
Type: Grand Marquis, 4-door sedan	Type: Ranger, pickup
Driver: 87-year-old male	Driver: male-unknown age
CDC: 10-LYEW-3	CDC: 99-0000-0

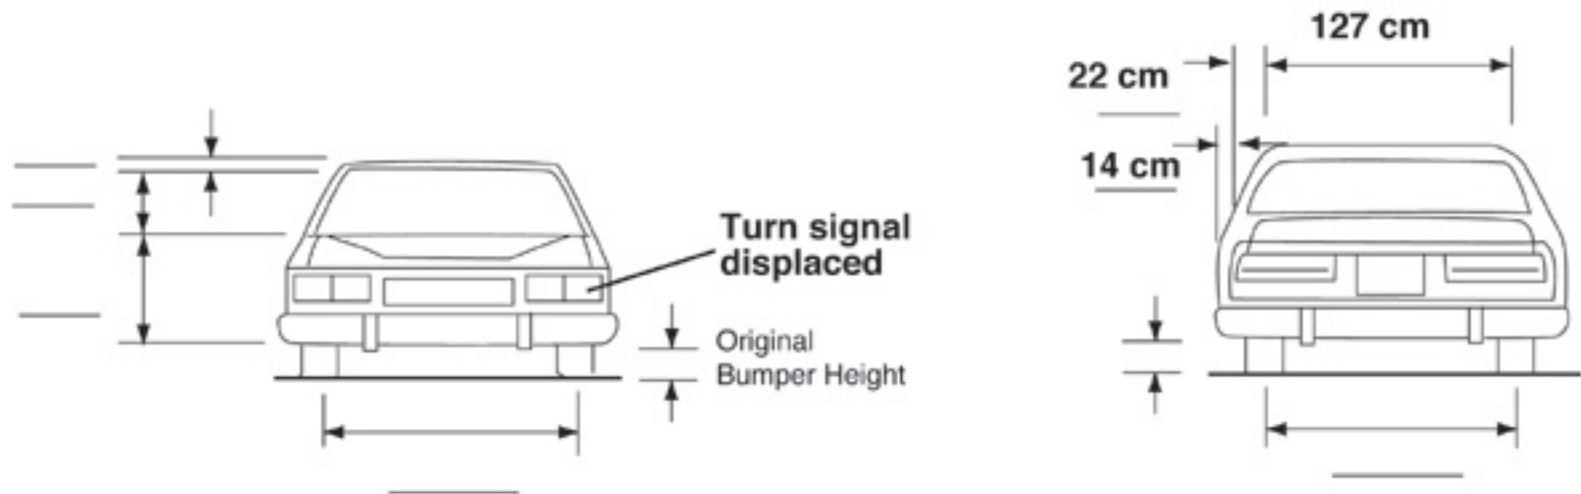
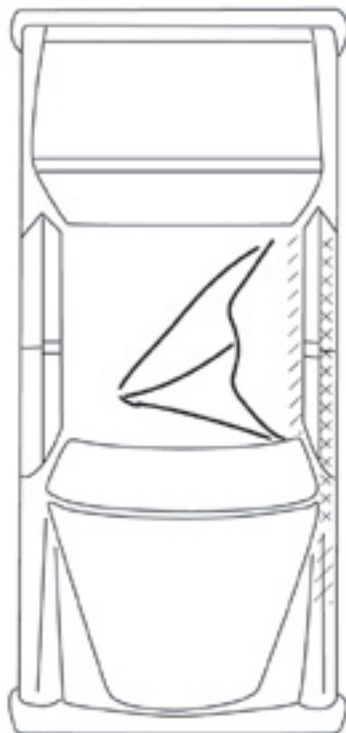
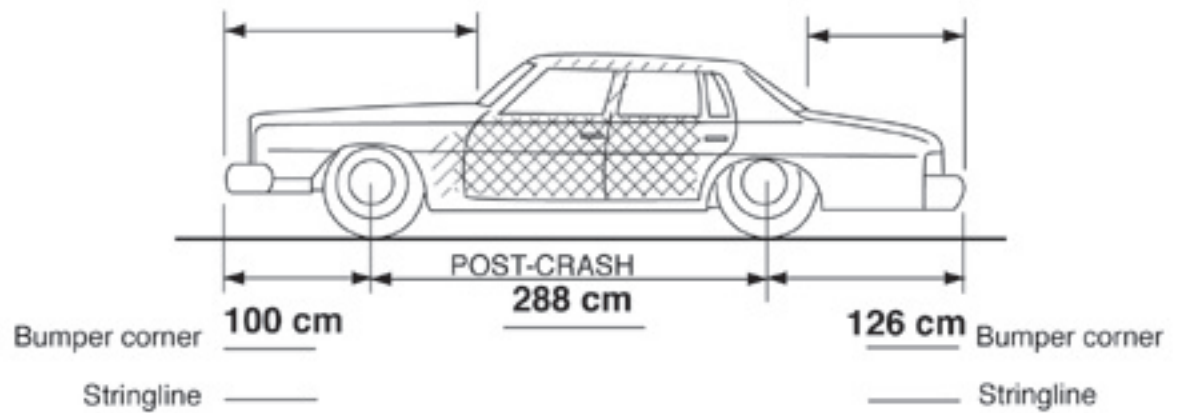
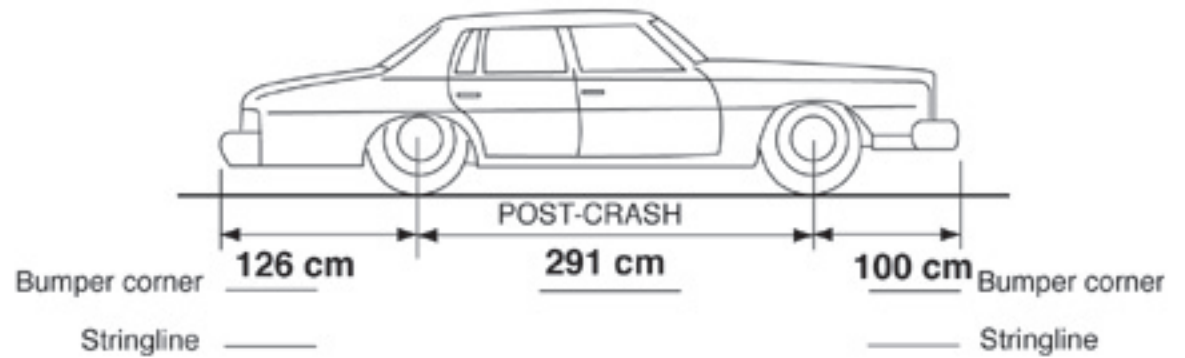
MEASUREMENTS IN CENTIMETERS

[3](#) The direct-damage length along the left side of case vehicle (A) was 188 cm and began just behind the left-front wheel and extended to the rear edge of the left-rear door. The maximum crush above the sill was 50 cm and occurred at the left B-pillar. The left wheelbase was reduced 3 cm, and the right wheelbase was unchanged.

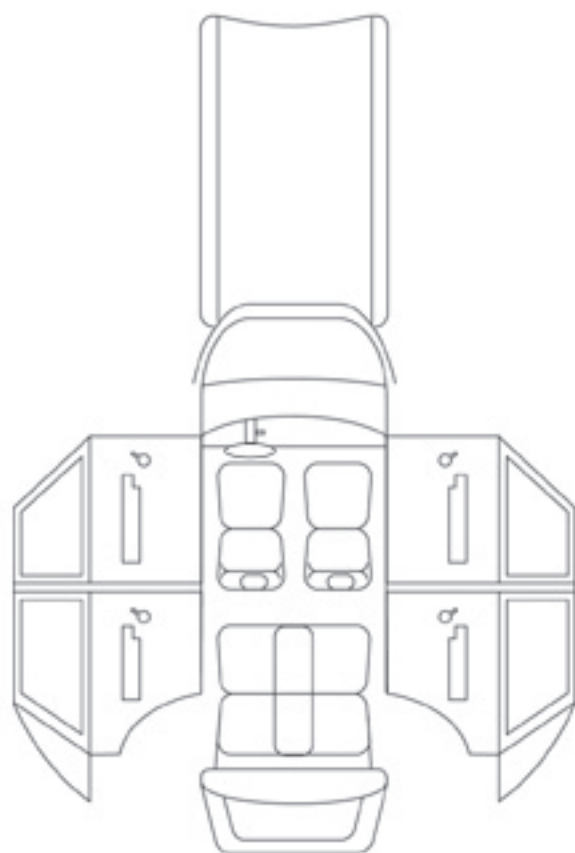
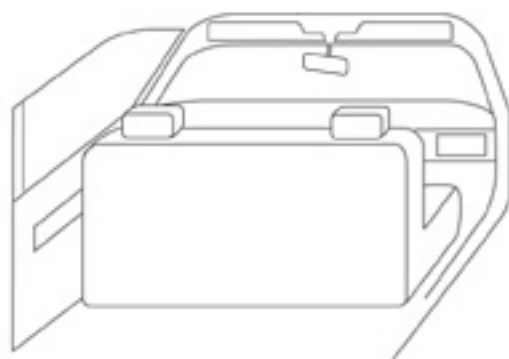
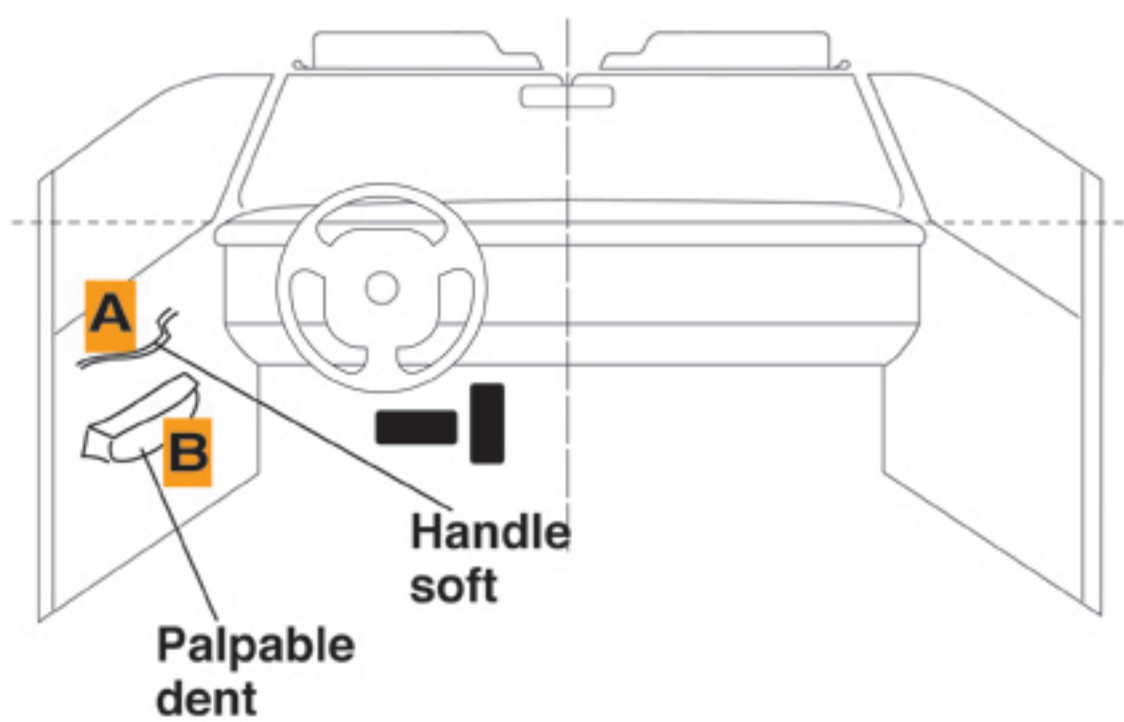
OCCUPANT CONTACT WORKSHEET

Contact	Interior Component Contacted	Occupant No. if Known	Body Region if Known	Supporting Physical Evidence	Confidence Level of Contact Point
A	Handle	1	Torso	Handle soft	1
B	Armrest	1	Torso	Palpable dent	1
C					
D					
E					
F					
G					
H					
I
